GEOPHYSICAL SURVEYS ON CARROLL COUNTY DAM

Abstract

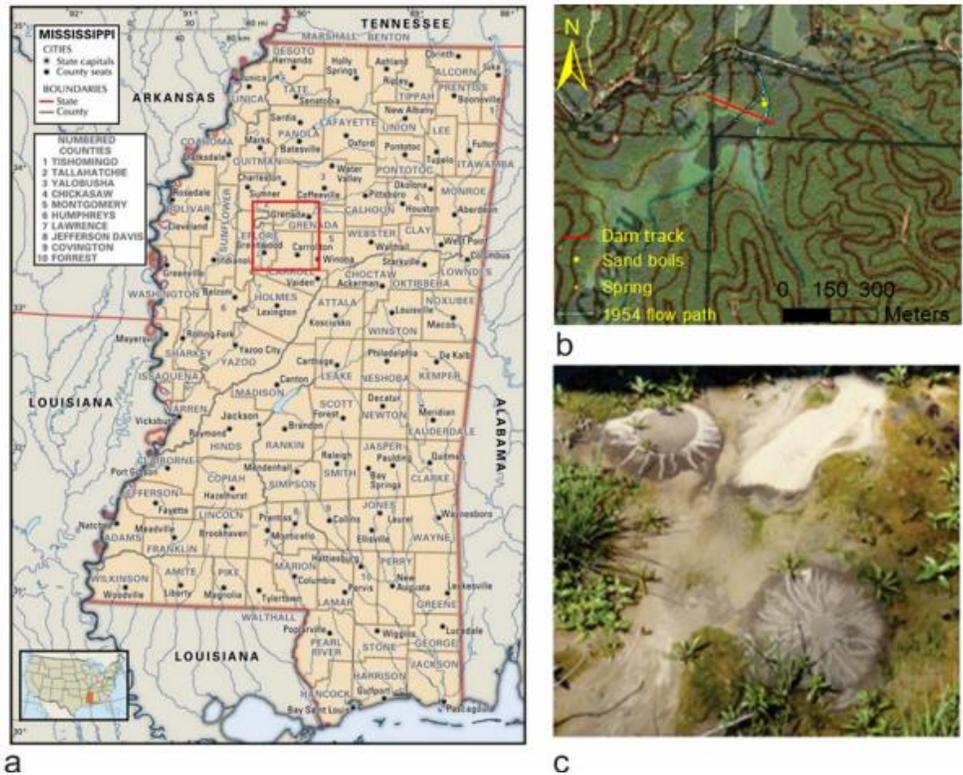
In March 2016, during a routine visual inspection by the Mississippi Department of Environmental Quality Dam Safety Division (MDEQ), moderate seepage and sand boil formation were observed at the toe of the dam (Figure 1c). Sand boils developed despite the dam retaining very little water and it raised concern about the dam integrity and the existence of seepage through the dam structure. During a flood event, when pore pressures increase significantly, the situation could deteriorate rapidly, and potentially lead to a dam failure. This is a high hazard dam with chance for loss of life downstream in case of failure.

Figure 1: a) Location of the study area. b) 1954 topographic map of the study area prior the dam construction. c) Pictures of the sand boils found dam downstream during the 2016 MDEQ inspection.

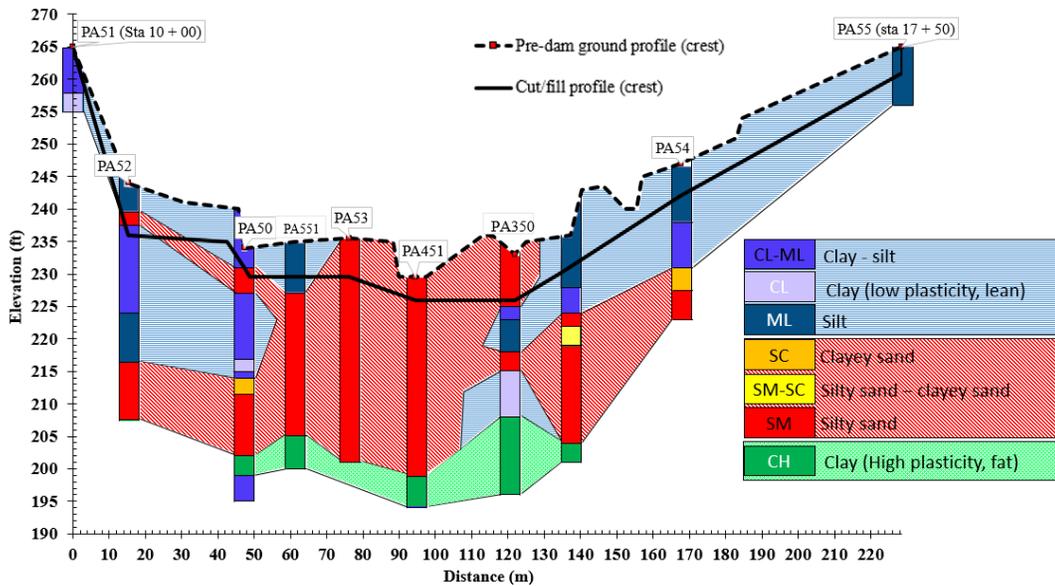
The geological baseline characterization for the dam has been derived from geological cross sections and borehole analysis reported in the as-built documentation. The cross-section in Figure 2 represents the subsurface geology along the dam’s crest profile. The dotted black line and the solid black line indicate the pre-dam ground and the cut/fill profiles, respectively. The dam was built to close the valley formed by the erosion of a small creek. The valley was about 6m (20 feet) deep and 183 – 213m (600-700feet) wide with both valley flanks formed by a combination of silt and clay with medium to low plasticity (ML, CL). A large portion of the valley subsurface consists of silty sand (SM), in some areas this formation reaches up to 12m (40 feet) thickness. Imbedded in the silty sand (SM)

formation are some lenses of gravelly clay or sandy clay (CL). According to the “As built” document, the dam construction involved the excavation of about five feet of material. The dam foundation is represented by high plasticity clay (CH) which is found at the bottom of boreholes PA350, PA451, PA551, and PA50 mainly in the middle of the old valley.

Figure 2: Geological cross-section illustrating the subsurface geology along the dam’s crest profile.

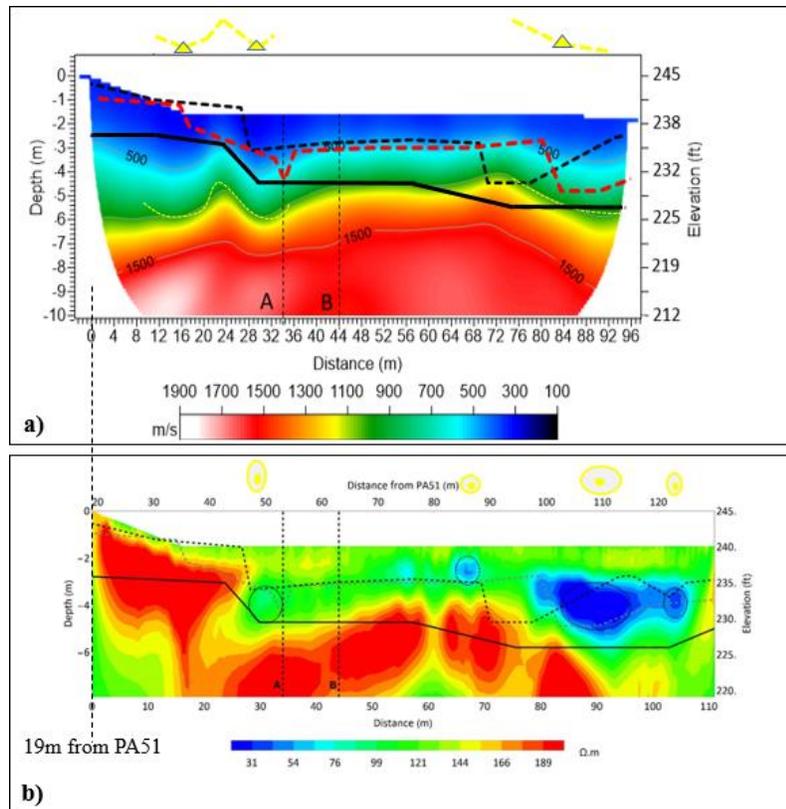
Both seismic and electrical data were analyzed to establish the presence of velocity and resistivity anomalies, particular attention was placed to locate areas where low p-wave velocity and low resistivity which could be representative of the presence of deteriorated material and active fluid-flow. Figure 4a (seismic tomograms) and Figure 4b (resistivity section) display the geophysical anomalies of line 3 (toe) which is used as example to illustrate how the geophysical anomalies are mapped. For both data sets, anomalies are annotated using a combination of dotted lines/polygons of different colors. Points of reference in Figure 3 and subsurface horizons (pre-dam topographic profile and cut/fill surface) in Figure 2 are projected onto the geophysical lines to help with the location of the anomalies.

Figure 4: a) P-wave velocity tomogram and b) resistivity tomogram for line 3 (toe). There is a sharp draw-down in the 500m/s and 1000m/s contour lines along intersection point A between depths 2m to 5m. Resistivity also drops near point A. A very shallow (at about 2m depth) circular low resistivity anomaly is present between 60m and 70m horizontal distance. There is also a large low resistivity anomaly extending from 85m to 105 m within the dam body.

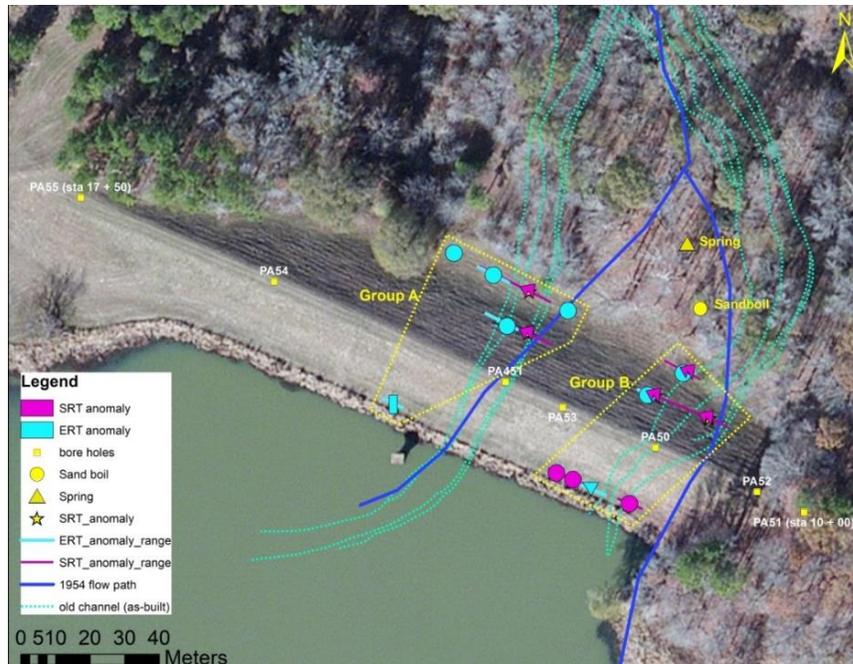
The planar distribution highlights that both ERT and SRT anomalies group in two particular areas of the dam: group A and group B. Both groups appear to follow the pre-impoundment surface hydrology, in fact, both groups line up close to the position of the old creeks. Within both zones, geophysical anomalies appear to be present from the waterside through to the dam toe; this is particularly evident for group B, where low resistivity anomalies, that might be indicative of active fluid flow, extend across the dam body. The location of the electrical anomalies in zone B project quite well to the sand boil location but are barely on the left boundary of the seasonal stream path. However, one needs to consider the accuracy of geolocating information from 50-year-old as-built plans and topographic maps.

Figure 5: Planar distribution of geophysical anomalies obtained from SRT and ERT survey lines 1, 2, and 3 are shown on a Google Earth image. The two groups of anomalies (group A and group B) are distributed in close proximity to the old channels.

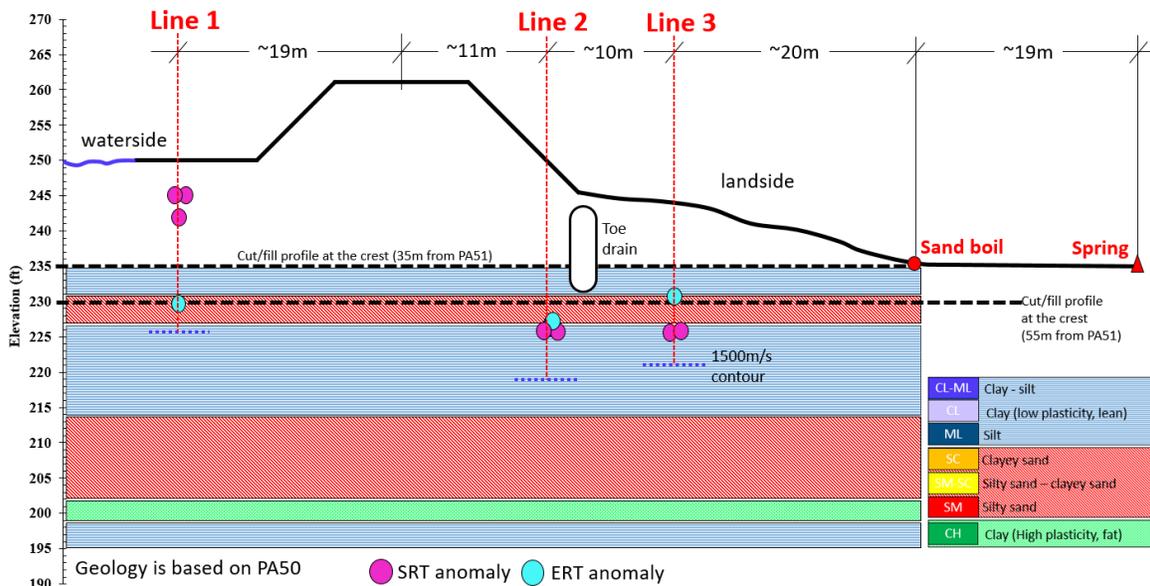
Figure 6 shows the distribution of geophysical anomalies, in group B, on a cross section of the dam from upstream to downstream. The geology displayed on Figure 6 is based on borehole PA50 (Figure 2) and the two horizontal dotted lines represent a range in depths of cut/fill profile at the crest using the elevations at 35m and 55m from PA51 (Sta 10+00) (Figure 2). Given the limited information, we project this interface horizontally from the upstream to downstream side requiring the cut/fill surface be level in that direction. That might not be the case. However, assuming a level cut/fill interface in the upstream to downstream direction the anomalies mostly occur at

depth below the base of the dam. Therefore, the active seepage observed downstream is not coming through the dam but is occurring within the confined sand layer between elevations 225ft and 230ft. Allowing for uncertainty in depth of a few feet (~5ft) the flow could be occurring at the cut/fill interface and located at the lower hinge point in the upward transition of the abutment (see Figure 4).

Figure 6: Vertical distribution of geophysical anomalies (group B only) obtained from SRT and ERT survey lines 1, 2, and 3 are shown on a cross-section (upstream to downstream) of the dam. Except for line 1 SRT anomalies, the anomalies occur at depth below the base of the dam indicating no seepage through the body of the dam.
