## **DETAILED NEAR SURFACE GEOPHYSICAL SURVEY AT AN AREA STRICKEN BY THE 2016 KUMAMOTO EARTHQUAKES**

*INAZAKI Tomio, Public Works Research Institute, Tsukuba, Japan*  
*KISANUKI Hiroshi, Public Works Research Institute, Tsukuba, Japan*  
*OGAHARA Takanori, Public Works Research Institute, Tsukuba, Japan*  
*ONISHI Kyosuke, Public Works Research Institute, Tsukuba, Japan*

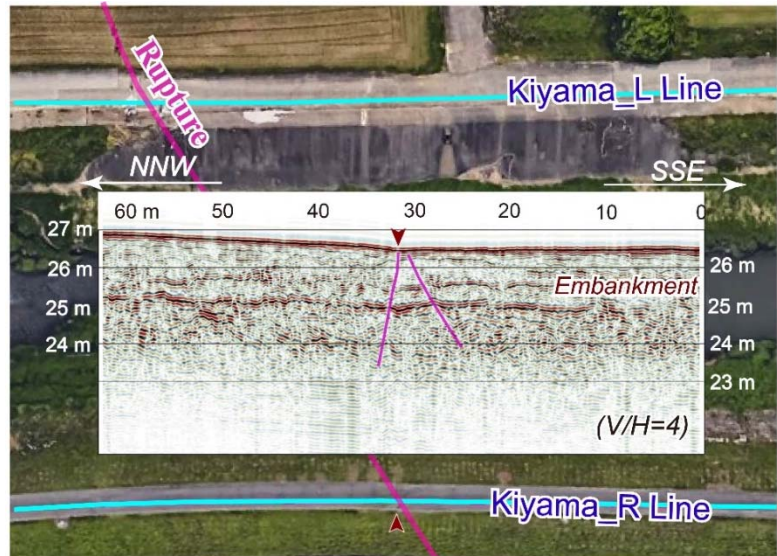
**Figure 2** is a typical GPR depth section along the line crossing the surface rupture. Surficial structure up to 3m or more was imaged using GPR. With the aid of RTK-GNSS positioning system, we could precisely locate each GPR trace (usually 1 cm intervals) position within 1 cm in horizontal and 2 cm in vertical accuracies. As clearly depicted in **Fig. 2**, levee's surface significantly bent at the point where the survey line intersects the surface rupture. Moreover, a reflection (*ca.* 25 m) from the bottom of levee showed a flexural deformation. It indicated that the rupture was associated with hinge faulting of right (SSE) side along with right-lateral strike slip displacements. Because banking works were conducted recently (Ca. 60 years ago), the observed deformation in the levee body was presumed to be juvenile caused by active faulting associated with the earthquakes.

**Figure 2.** A part of GPR depth section along Kiyama\_R line. Note that surface and the bottom of embankment are bending at a point (red triangle) where the line intersects the surface rupture.

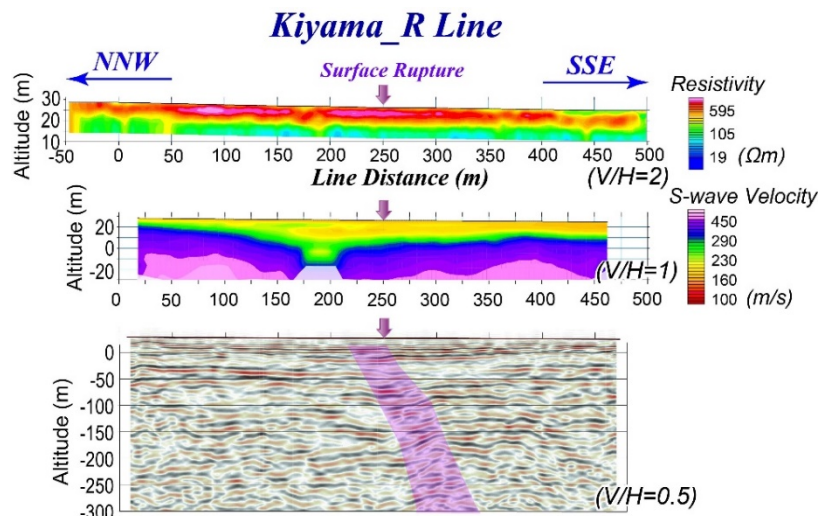
**Figure 3** compares other depth sections along the 480 m long Kiyama\_R line. The top one is a resistivity section, imaging up to 15 m deep reconstructed from OhmMapper data (vertical exaggeration ratio is 2). As seen, a thin relatively high resistivity layer covered the surface underlain by thick relatively low resistivity layers. The middle section delineates an S-wave velocity structure derived from HSWS data (vertical to horizontal ratio is 1). Owing to the

**Figure 3.** Depth sections along Kiyama\_R line; Resistivity (top), S-wave velocity (middle), and a migrated P-wave seismic reflection depth section (bottom) reconstructed from HSWS records.

advantages of the HSWS method, we could reconstruct a velocity structure up to 50 m in depth. It is characteristic that a 50 m wide low velocity zone appeared at 200 m in line distance. This was interpreted as a buried meandering channel of old Kiyama River not as a low velocity zone associated with faulting, based on an aerial photogrammetric analysis.

Bottom is a migrated depth section reconstructed through P-wave seismic reflection processing for HSWS records. Owing to dense setting of geophones and shot points, we could obtain a high-resolution reflection section which successfully delineated a right side upthrown (reverse faulting) flexure structure showing cumulative displacements beneath the surface rupture. The reconstructed structure beneath the surface rupture strongly indicated that it was an active fault repeatedly dislocated the subsurface layers.

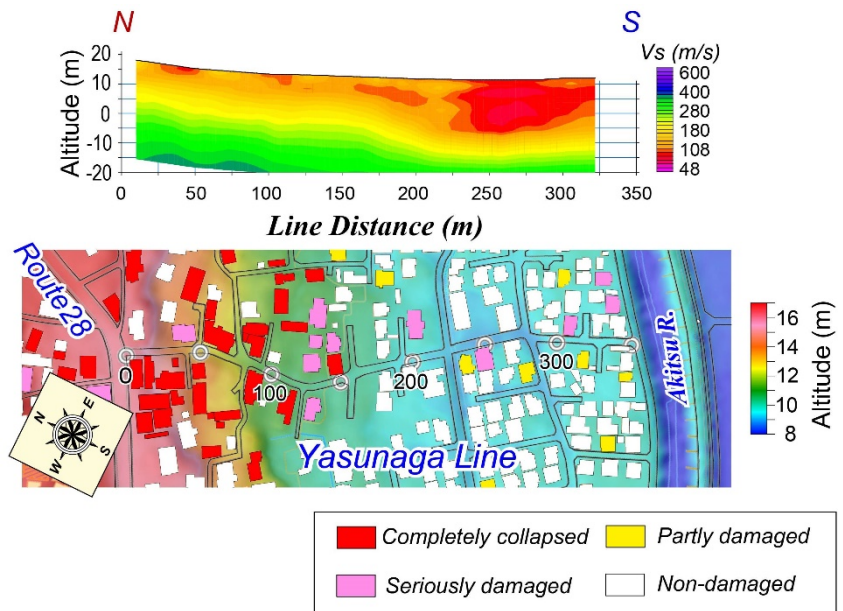
**Figure 4** is an S-wave velocity section along Yasunaga Line, placed in the “heavily damaged zone” in the downtown Mashiki. HSWS data processing enabled to provide relatively deep section compared with conventional active surface wave survey. We could image a layered structure up to 35 m deep. Note that thick low velocity layer appeared at the southern (right) part of the line, or the lowland around Akitsu River (**Fig. 1**). In contrast, heavily damaged houses were concentrated at the northern part (left side) of the line where the surface  $V_s$  was not so low. This strongly indicated that the surface  $V_s$  structure was not the primary cause of the house damage. It is possible that existence and types of foundations affected the seismic stability of wooden houses.

**Figure 4.** S-wave velocity structure (upper) and a survey line map (lower) of Yasunaga Line. Damage of each wooden house around the line was classified into 4 grade based on “street view” of Google Maps.
