PSEUDO THREE-DIMENSIONAL IMAGING OF CREEP FAILURE IN A HIGHWAY EMBANKMENT USING TWO-DIMENSIONAL ELECTRIC EARTH RESISTIVITY

Riley J. Balikian, Illinois State Geological Survey, Champaign, IL
Timothy H. Larson, Illinois State Geological Survey, Champaign, IL

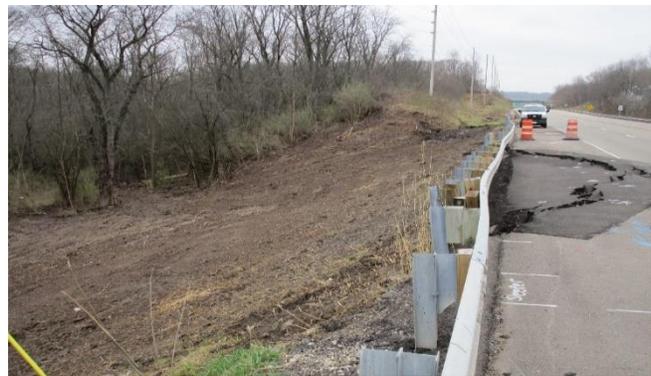
Problems with this embankment have been evident ever since it was first constructed in 1962, with creep failure occurring in the subsurface along the roadway as it crosses the stream channel. The failure has reached the shoulder of the roadway causing a hazard (Figure 2). The topography in 1962 prior to construction—along with the study area and the planned road—are shown as a three-dimensional model in Figure 3.

Figure 2: Failure in the subsurface of the embankment is causing damage along the roadway. This photo (facing south) was taken the month prior to the ERT survey.

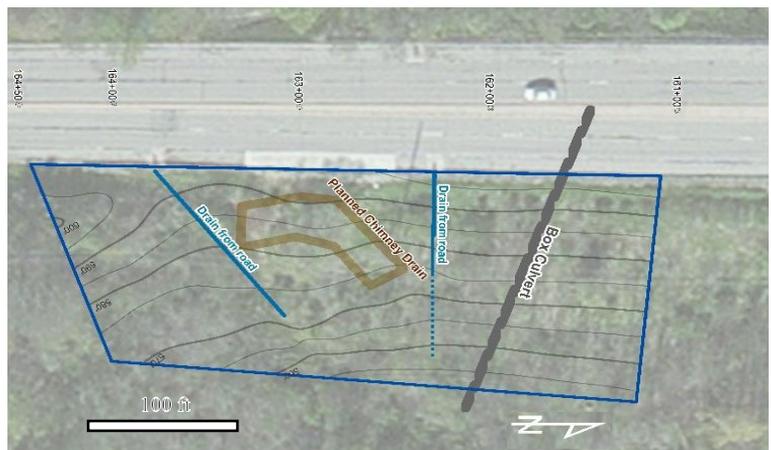
Figure 5: Subsurface structures in the study area. The chimney drain is shown in its planned location. The dotted line in the drain may be where the pipe transitions from metal to plastic, as indicated by relatively higher resistivity values.

The shallow, relatively high-resistivity material imaged on profiles 1-4 appears to be a more recent fill material. It is in the same general area as a chimney drain which appears in IDOT repair plans, but whose construction was not confirmed. Two areas of relatively high resistivity just north (Profile 5) or just below (Profile 6) the northern drain pipe are interpreted as artifacts related to the drain pipe, but they may also be a northern continuation of the fill material imaged on profiles 1 through 4. The features described above are fairly well-imaged on the resistivity profiles. Based on the consistent resistivity values and locations of the features we are relatively confident in our interpretations.

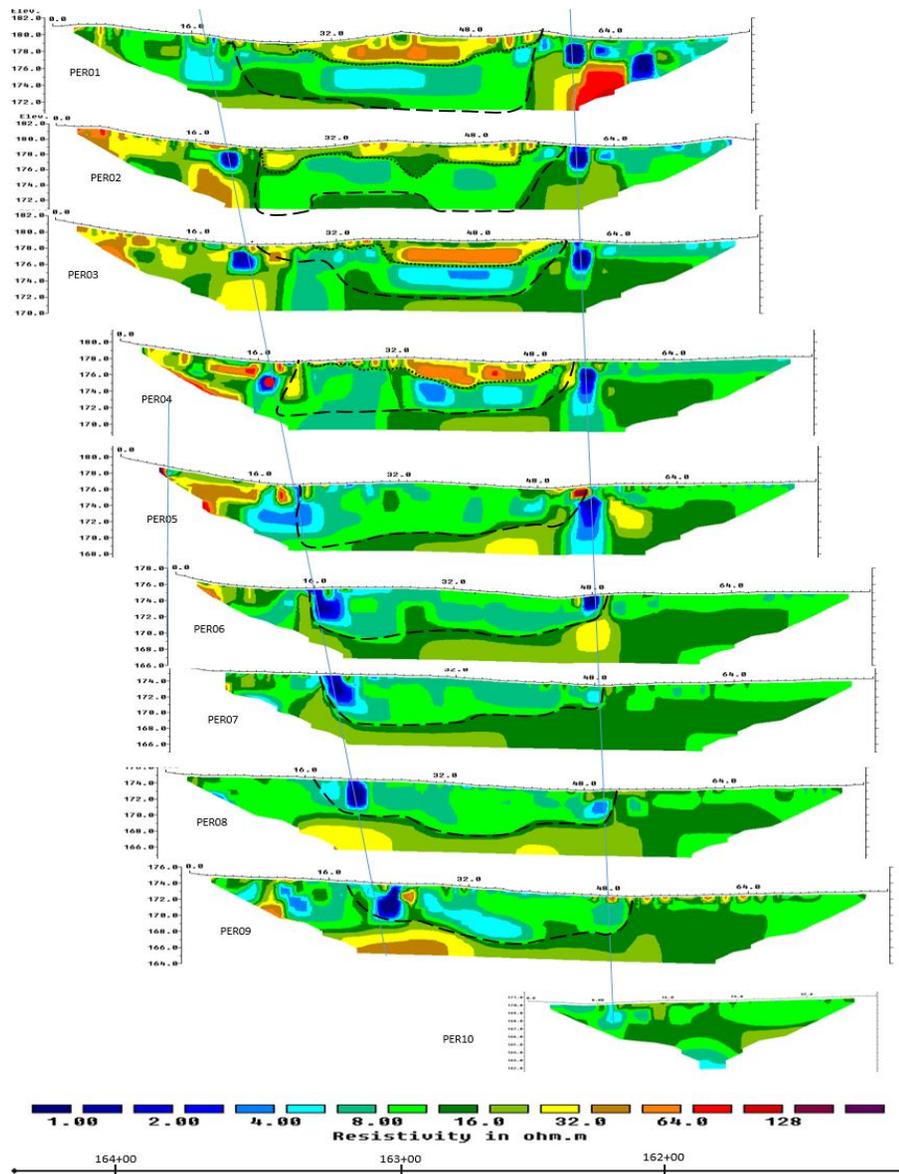
Figure 7: The 10 resistivity profiles in this project, laid out to scale horizontally and vertically. IDOT markers are shown along the bottom of the profiles. Drain pipes are delineated by blue lines, the estimated failure surface is shown by large dotted lines, and a high resistivity area believed to be a chimney drain is shown by small dotted lines.

Figure 6 shows the 10 resistivity profiles at their relative locations at the site. Two shoulder drains had been installed during previous repairs. Because no as-built drawings exist, it was not clear where the drains led away from the roadway. The two drainpipes are clearly imaged on the resistivity profiles (the two blue lines/red dots). The northern pipe is perpendicular to the roadway. The southern pipe angles to the north as it proceeds downslope. This, in itself, is an important result of the survey as it provides precise information to IDOT for planning future repairs. In addition, the low-resistivity anomalies at two locations on nearly every line provided us a means to confirm alignment of the resistivity profiles one-to-another. Unfortunately, the very low resistivity values of the pipes distort the rest of the image and various artifacts can be seen in the inverted resistivity profiles. This makes interpretation of the creep failure surface difficult because the pipes seem to be very near important interfaces in the failure and thus obscure the imaging of the failure. The northern drain pipe appears to transition to a material with higher resistance between profiles 6 and 7—perhaps plastic or another non-metal. The low resistivity zone at the base of the tenth profile is consistent with the box culvert carrying the re-routed stream. However, this interpretation is far from definitive. These and other subsurface features are also shown in Figure 5.

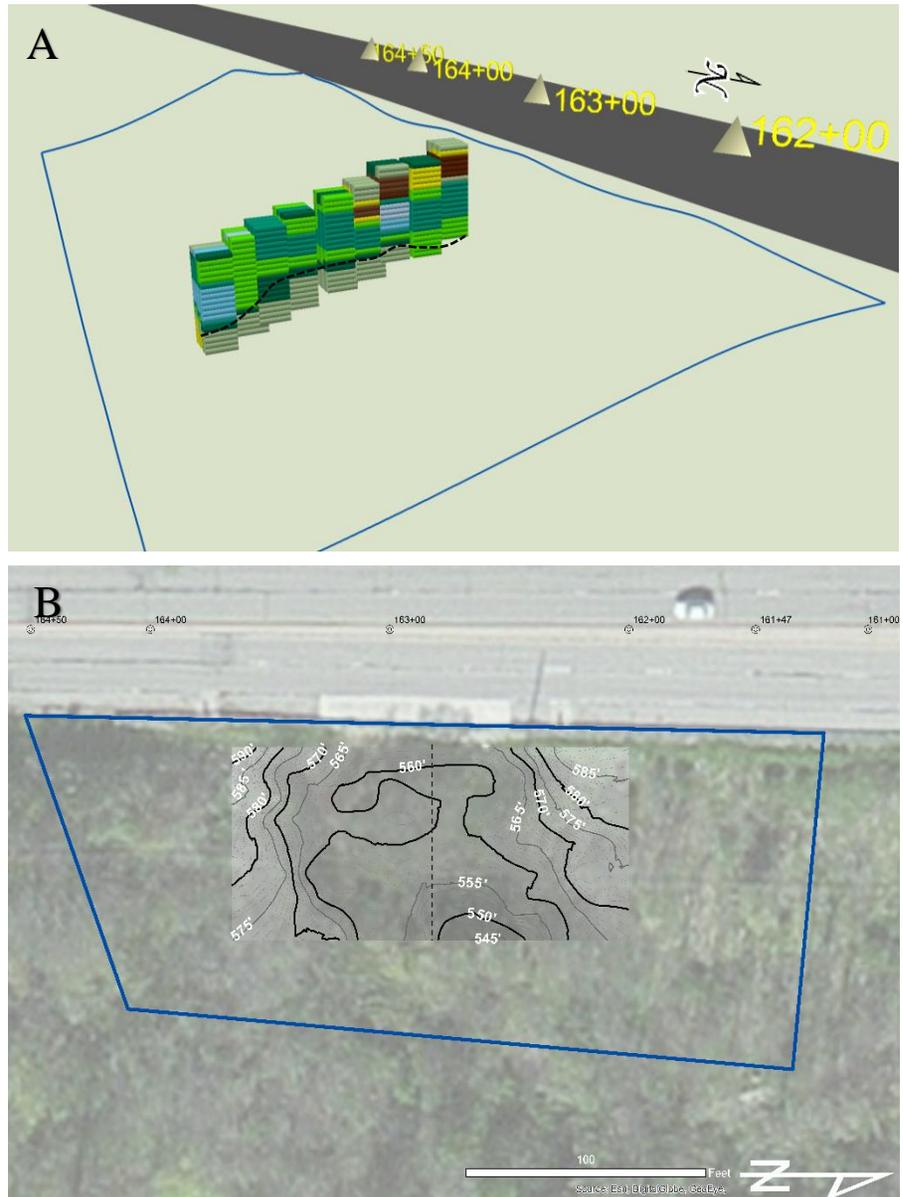
Figure 6: A) A 2-D profile of the subsurface using a single column of points from each profile 1-9, with a dotted line indicating the estimated failure surface. B) A contoured image of the failure surface. The dotted line shows the location of the profile in 6A.

The primary purpose of this survey was to delineate the elevation at which the failure is occurring. Because the resistivity profiles are close together, we were able to compare them for features, which may be subtle on any one profile, but when repeated on adjoining profiles suggest the presence of a physical interface and not merely noise in the resistivity data. In particular, a linear feature can be seen near the center of the base of most of the profiles (Figure 6). It separates a zone of relatively higher resistivity material below from a zone of relatively lower resistivity material above. The north and south boundaries of this feature are often obscured by artifacts from the buried drain pipes; however, we believe we can trace the edges with some confidence in most of the profiles.

We also show this feature in profile on Figure 7a. We create a contoured surface, shown in Figure 6 and Figure 7b. This surface is consistent with a slip surface between the competent slope (higher resistivity material) and a mass creep of the lower resistivity material. The southern edge of this surface, though difficult to precisely image because of the presence of the drain pipe, appears to be fairly steep and to abut the zone of the relatively highly resistive undisturbed material on the far south end of profiles 2 through 6. On the north, the surface gradually moves farther north as it moves downslope.

In response to these findings, IDOT installed inclinometers at the site to verify these results and further delineate the slip-face. According to the inclinometers, at the location of greatest movement, the ground has been moving at a rate of 0.025 inches/day (1.1 inches over 6 weeks). The interface between the stable ground and the creeping ground was within 1 foot of our estimation at all the recorded points except one (where it was within 3 feet of our estimation). Where we had predicted no movement in the subsurface, the inclinometers confirmed that the subsurface was stable.
