Geo# Hazards

- Brian Herridge Memorial
- The Active Faults of Harris County: A Selfpaced Field Guide
- Geophysical Investigations for the Emergency Response to the February 2017 Spillway Failure at Oroville Dam, California
- Front Yard Geophysics in Northern Austin: Location of a Significant Karst Anomaly in Austin Chalk, Travis County Texas

Geophysical Investigations for the Emergency Response to the February 2017 Spillway Failure at Oroville Dam, California

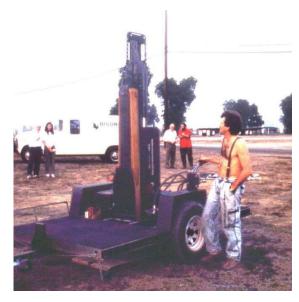
Brian had other talents, like welding for example, and if he had an idea he would go out to his shop and put it together. He built a seismic energy source which used a giant rubber band to accelerate a weight. Playing on the rubber band, he named it "the elastic wave generator". Of course, his elastic wave generator evolved into many variations of the "accelerated weight drop" that you see today.

His interest in sources continued to this day and he built an assortment of more powerful versions, including one pictured here with a 2000-pound mass. Brian believed

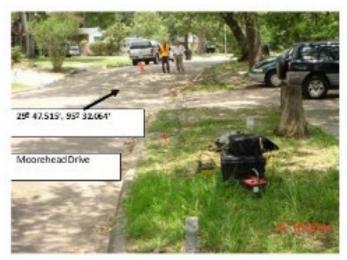
Figure 4. Picture showing coordinates of the Long Point fault scarp on the road and the location of resistivity profile. The view is to the north.

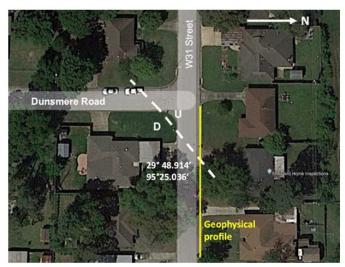
Figure 8. Site map showing the approximate location of the Eureka fault crossing West 31st Street and Dunsmere Road. Fault deformation is highly visible on the asphaltic pavement of West 31 Street. The yellow line indicates the location of geophysical profiles.

Geologic overview: The fault crosses West 31st Street and Dunsmere Road (Figure 8). Fault deformation is expressed as cracks on West 31st street that extend 75 feet across the intersection. The fault is about seven miles long. It crossesmany residential places and commercial buildings.

Resistivity and GPR were conducted along the North edge of West 31st Street (Figures 8 and 9). Collecting these data were challenging due to the location of utilities, and insufficient contact between electrodes and fill material in driveways (see Figure 8). However, the resistivity data indicates a significant fault anomaly (Figure 10). In Figure 10, the blue color is interpreted to represent clay lithology and the shape of the blue anomaly is interpreted to represent fault offset.

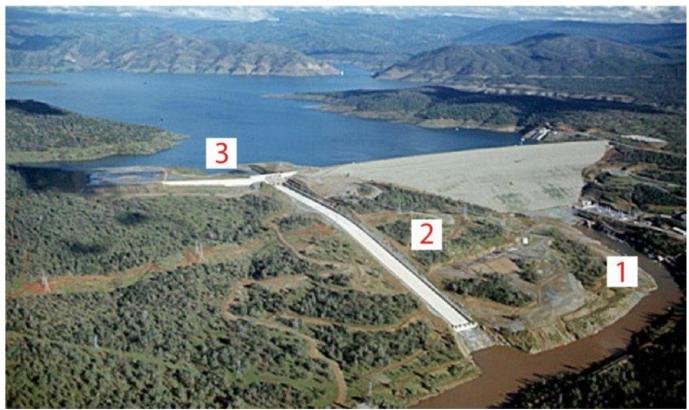
Figure 1. Lake Oroville Dam and Reservoir, circa 2015 (before spillway failure). Outflows from the reservoir are controlled from the three locations: 1) power plant, 2) Main Spillway, and 3) Emergency Spillway.

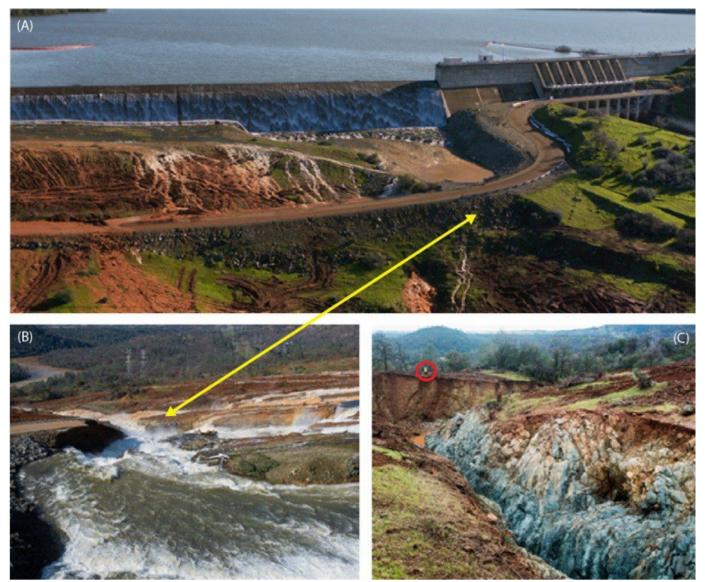
Figure 4. Views at the Emergency Spillway (A) during overtopping on February 11, (B) downstream view from the crest during peak flows, showing washout of the access road (arrow indicates relative location), (C) post-flow, near the former access road, showing extent of downstream erosion and channelization (Photo by author; note the human inspector in the background (circled for scale).

By February 10, reservoir inflows exceeded the established combined discharge capacities of the power plant and the crippled Main Spillway. On February 11, the Emergency Spillway at Oroville was activated for the first time in its history. Although erosion was anticipated downstream of the Emergency Spillway, the extent could not be fully predicted. The uncontrolled discharge caused erosion and channelization as it flowed down the unprotected natural terrain, with head-cutting

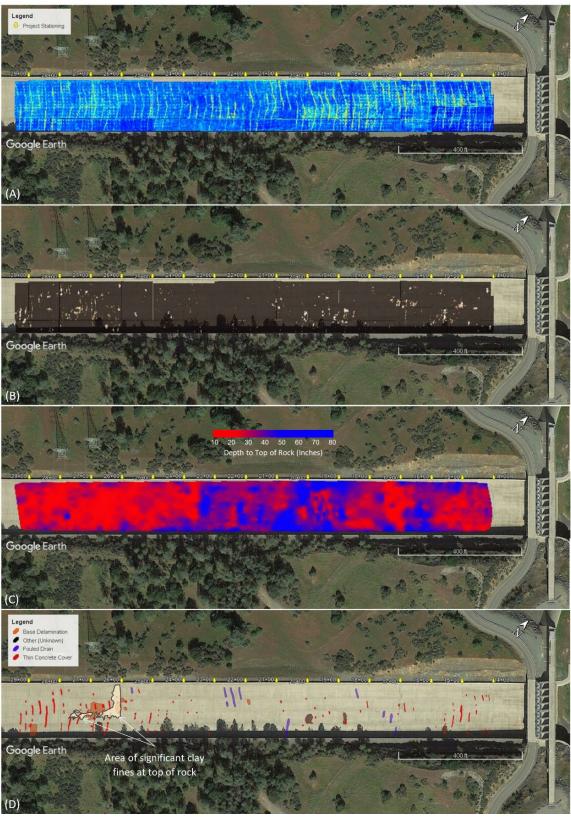
Figure 7. Plan View GPR maps produced for the Main Spillway. (A) Distribution of VCP drains and anchor mesh mats. (B). Discontinuities in bedrock below concrete. (C) Concrete thickness estimates. (D) Interpreted defects. Yellow arrows indicate project stationing. From Owen and Mallah (2017). See text for additional discussion.

The subdrains were conspicuous on the GPR profiles (Figure 6), and the herringbone pattern of the drains and gravel filter were readily visible in plan view (Figure 7A). These features are artificially induced voids, so they gave us some idea of how a void beyond the drains should appear. We also observed reflections from the lower reinforcing mesh (Figure 7A), and ringing off the vertical rebar of the rock anchors was seen at most locations (Figure 6).

and confirmed during demolition of the spillway during replacement the following year (IFT, 2018). Figure 7D includes the extent of clay fines observed during spillway demolition overlaid on the GPR interpretations. Figure 8B includes a photo taken of that exposed rock surface during demolition.

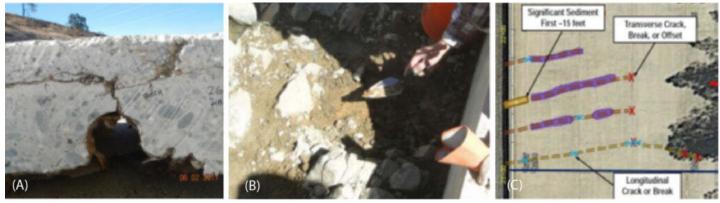
Figure 8. Results from destructive testing acquired during emergency response at the Main Spillway. (A) Thin concrete cover above a VCP drain in the vicinity of Station 26 (note lack of gravel filter blanket). (B) Sand and silt deposits above the bedrock surface in the vicinity of Station 26. (C) Results of video inspection of VCP drains at Station 22. From IFT (2018)., Appendix D and Appendix I.

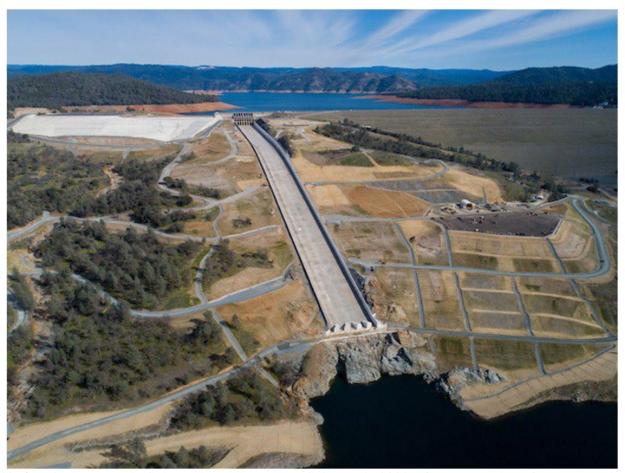
Figure 13. Oroville Dam Main Spillway and Emergency Spillway in 2020, after completion of reconstruction efforts.

DWR contractors began rebuilding the Main and Emergency spillways in May 2017. Emergency repairs on the Main Spillway were completed in November 2017 to allow controlled discharges as needed to maintain safe reservoir levels. In 2018, the secant cutoff wall and

splashpad were completed at the Emergency Spillway to mitigate future headcutting and erosion in the event of activation. By 2019, reconstruction of the Main Spillway to current design standards was completed (Figure 13). Grading of the eroded areas was completed in 2020. Revegetation of the damaged areas is ongoing.

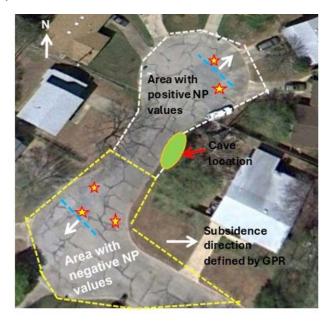
Figure 7. Locations of positive and negative NP values.
