PSEUDO THREE-DIMENSIONAL IMAGING OF CREEP FAILURE IN A HIGHWAY EMBANKMENT USING TWO-DIMENSIONAL ELECTRIC EARTH RESISTIVITY

Riley J. Balikian, Illinois State Geological Survey, Champaign, IL
Timothy H. Larson, Illinois State Geological Survey, Champaign, IL

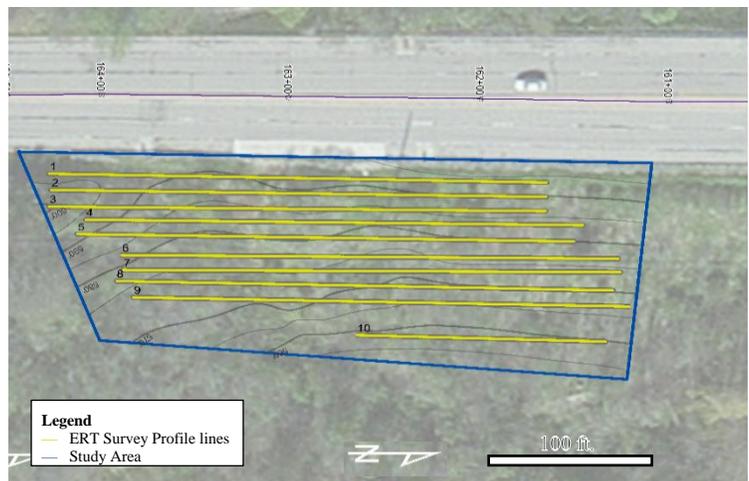
For the ERT measurements conducted in this survey, 40 metal electrodes were pushed into the ground at intervals of 2 meters along each survey line. Nine survey profiles were taken, each measuring 80 meters long; a tenth survey profile was also taken with only 20 electrodes, measuring 40 meters long (Figure 4). The stakes were connected through multi-core cable to a computer-controlled resistivity meter (ABEM Terrameter 4000) and switching system (LUND imaging system). A control program sequentially switched various combinations of electrodes, operated the instrument, and stored the data.

Figure 4: A) The 10 ERT profiles overlaid on elevation contours (feet) taken from the day of the measurement. IDOT markers (e.g., 161+00) are shown along the centerline of the road.
